J & J PROPERTIES  
ROOF EVALUATIONS  
4201, 4130, AND 4128 N FIRST  
ABILENE TX 79603  
CENTURY FILE: 0107555  
HAAG FILE: 0111002404-120

Re: J & J Properties  
Roof Evaluations  
4201, 4130, and 4128 North First  
Abilene, TX 79603  
Century File: 0107555  
Haag File: 0111002404-120

Complying with your request, we inspected the roof coverings at the captioned locations to determine the extent of hail damage, if any. Our inspection was conducted on September 16, 2011.

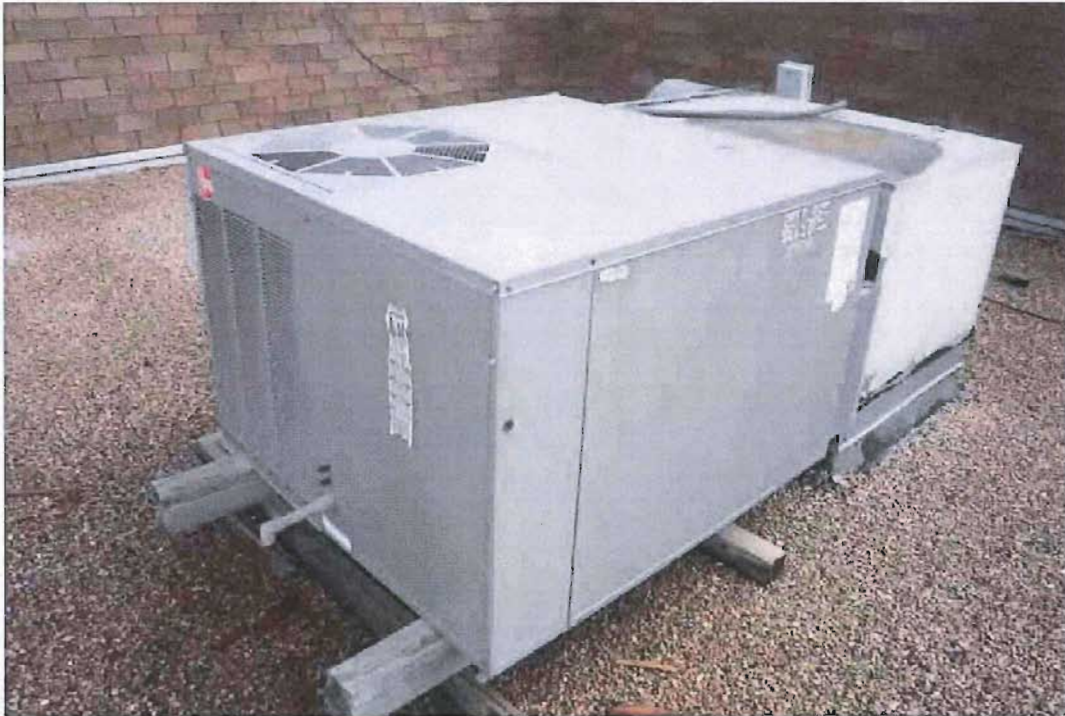
The built-up roof at this location was in good condition. The vast majority of the roof was covered with sufficient loose and embedded gravel. No blisters or wrinkles were detected in the roof membrane. However, condensate from the air conditioners was allowed to drain onto the roof. The control joint in the middle of the roof was not flashed properly and was just covered with a modified bituminous membrane. (Refer to Photographs 37 through 42.)

41. 4201 BLDG – Condensate from air conditioner drains onto roof.

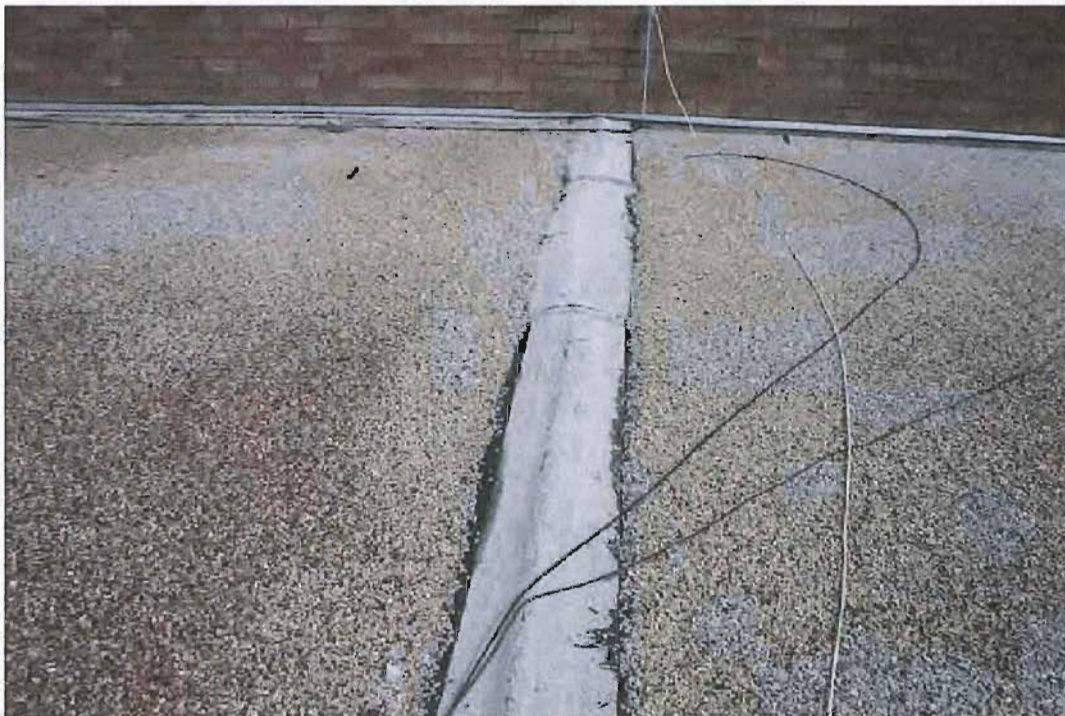
42. 4201 BLDG – Improperly flashed expansion joint.

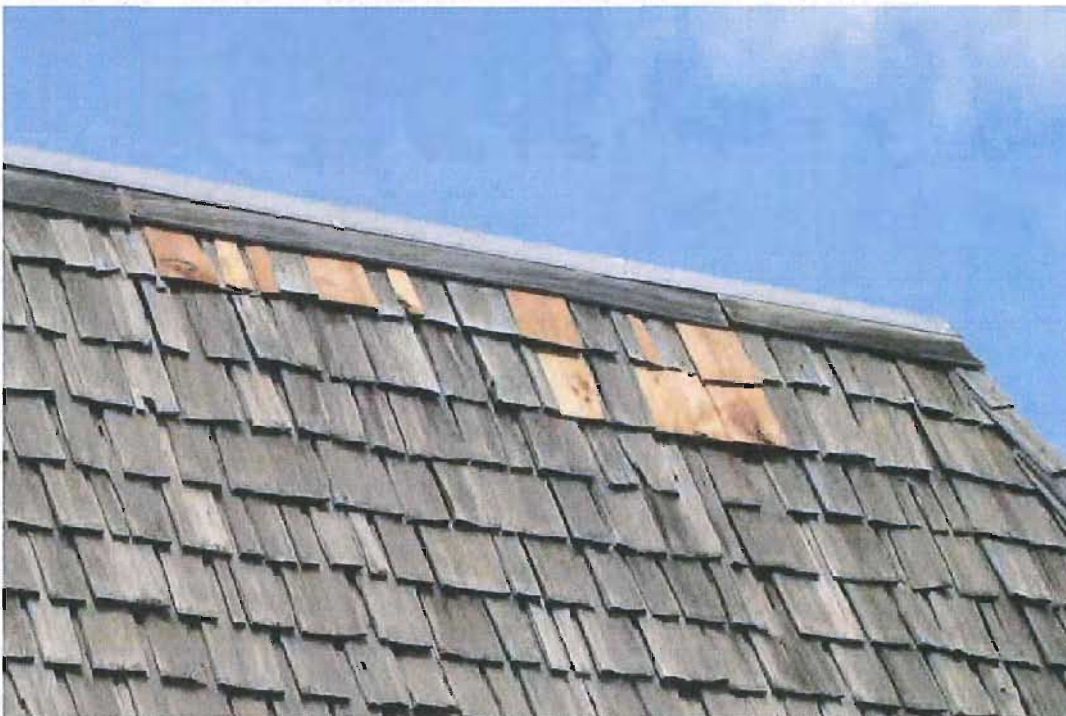
Cedar shakes on the mansard were in a deteriorated condition. There were a number of weathered splits in the wood. Recent insert repairs had been done to the mansard using low grade wood that contained knots. The inserted shakes were not weathered, indicating the repairs were performed recently. Asphalt shingles were in good condition with little evidence of weathering or embrittlement. However, some shingle slippage was noted. Close examination revealed the shingles were not nailed or sealed correctly for being on such a steep slope. Vertical tears were noted where shingles had slid downslope. (Refer to Photographs 43 through 50.)

44. 4201 BLDG – Recent repairs to mansard.

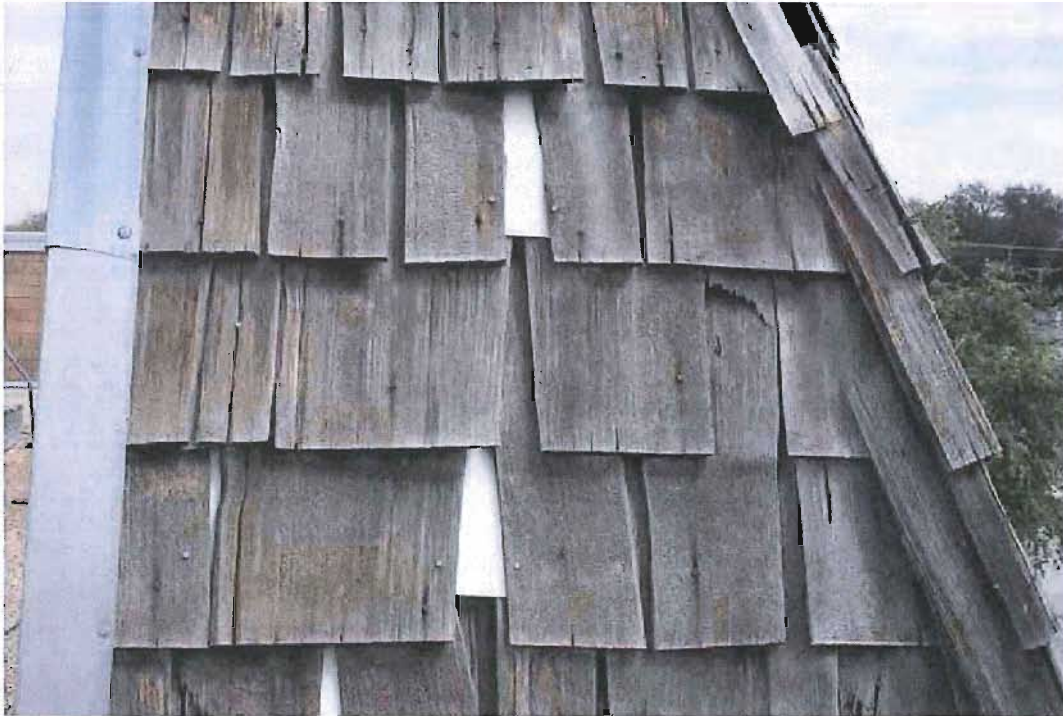
45. 4201 BLDG – Shim repairs on mansard.

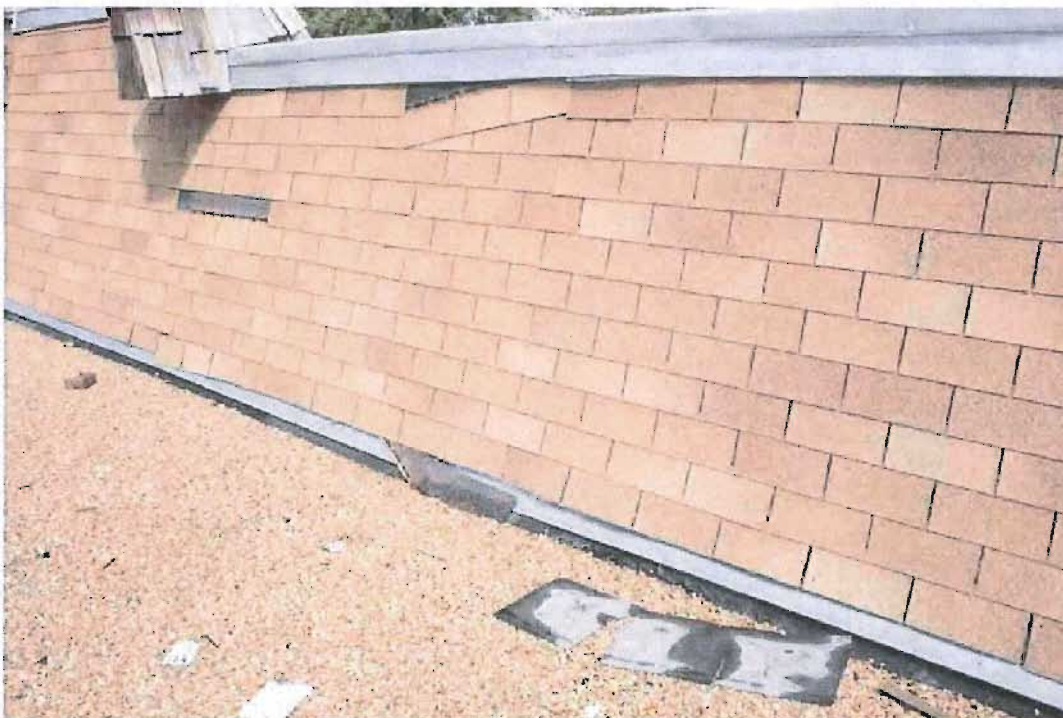
46. 4201 BLDG – Slippage of some shingles on back of mansard due to improper fastening.

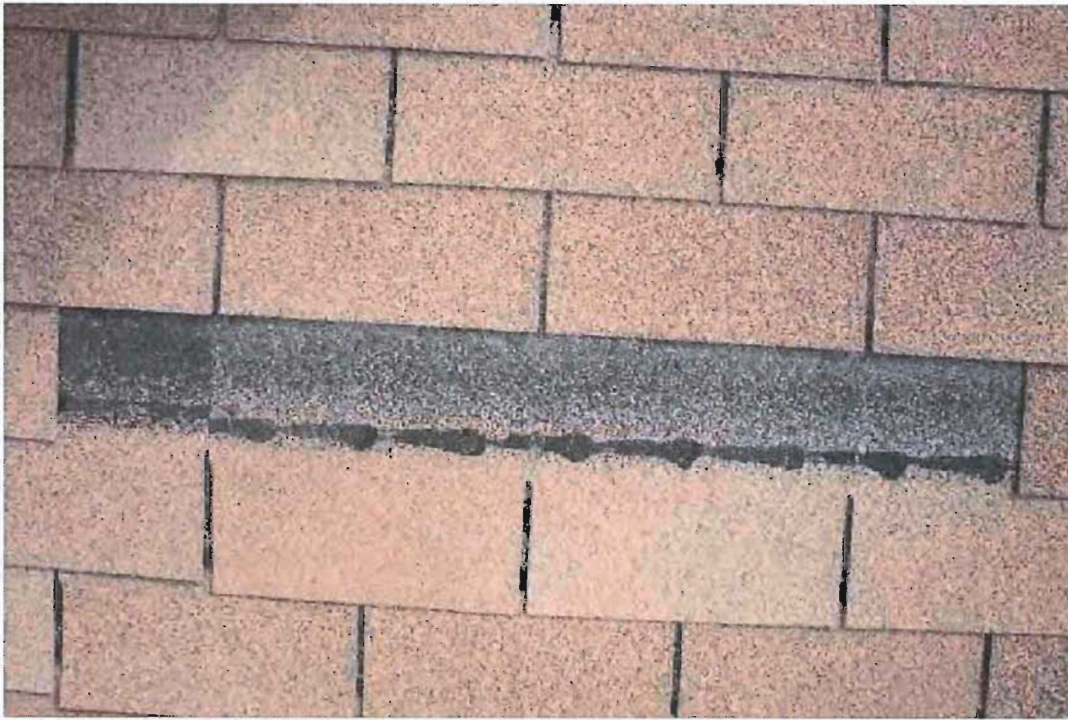
47. 4201 BLDG – Old missing shingle. Note rusted nails.

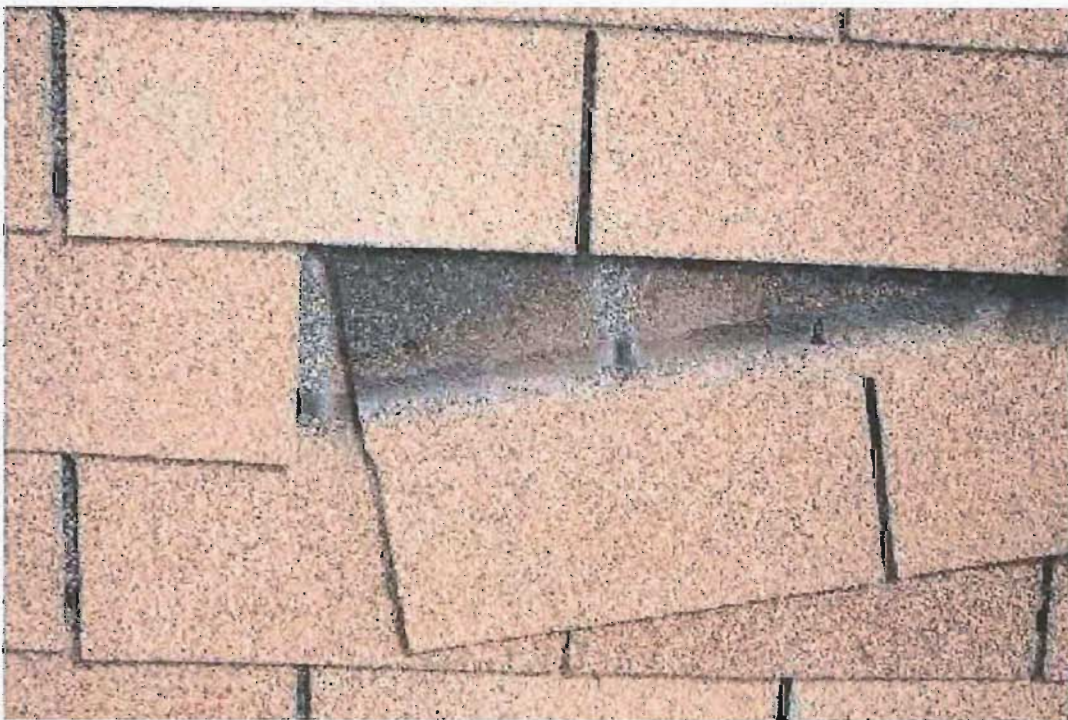
48. 4201 BLDG – Shingle slid downslope.

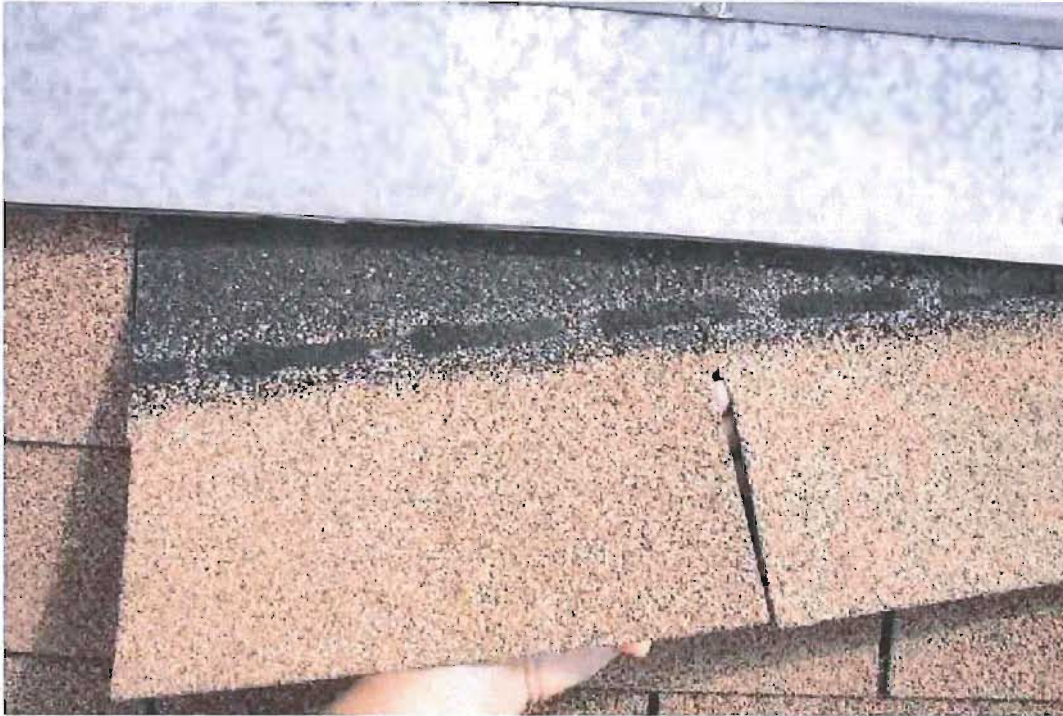
49. 4201 BLDG – Another shingle slid downslope.

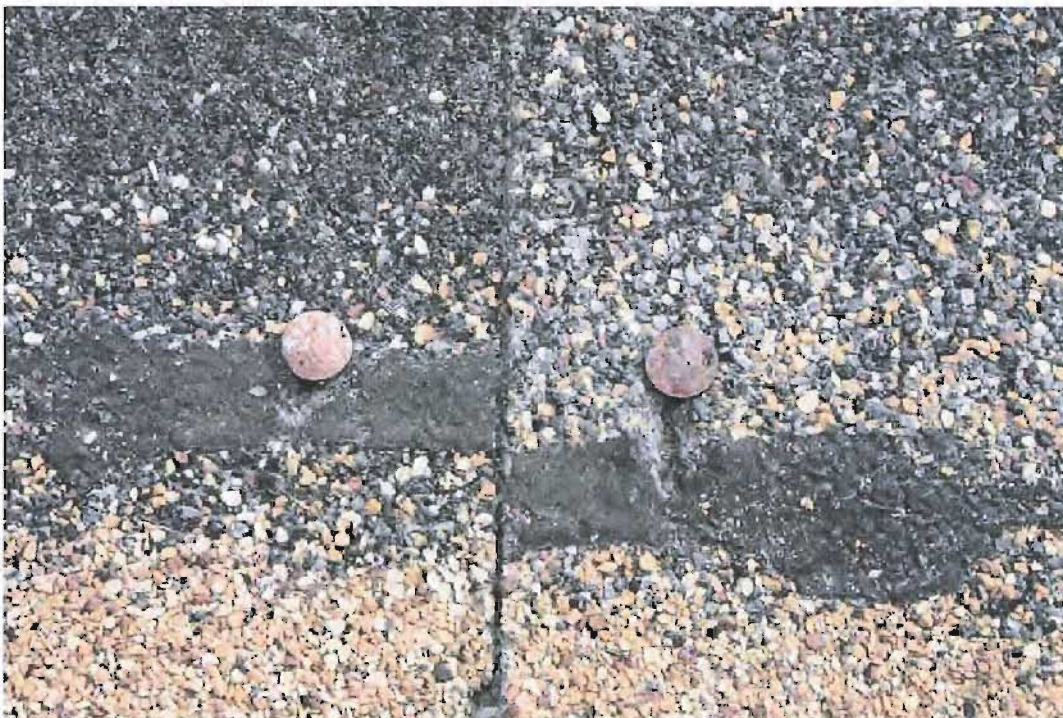
50. 4201 BLDG – Vertical tear (right) beneath fastener.

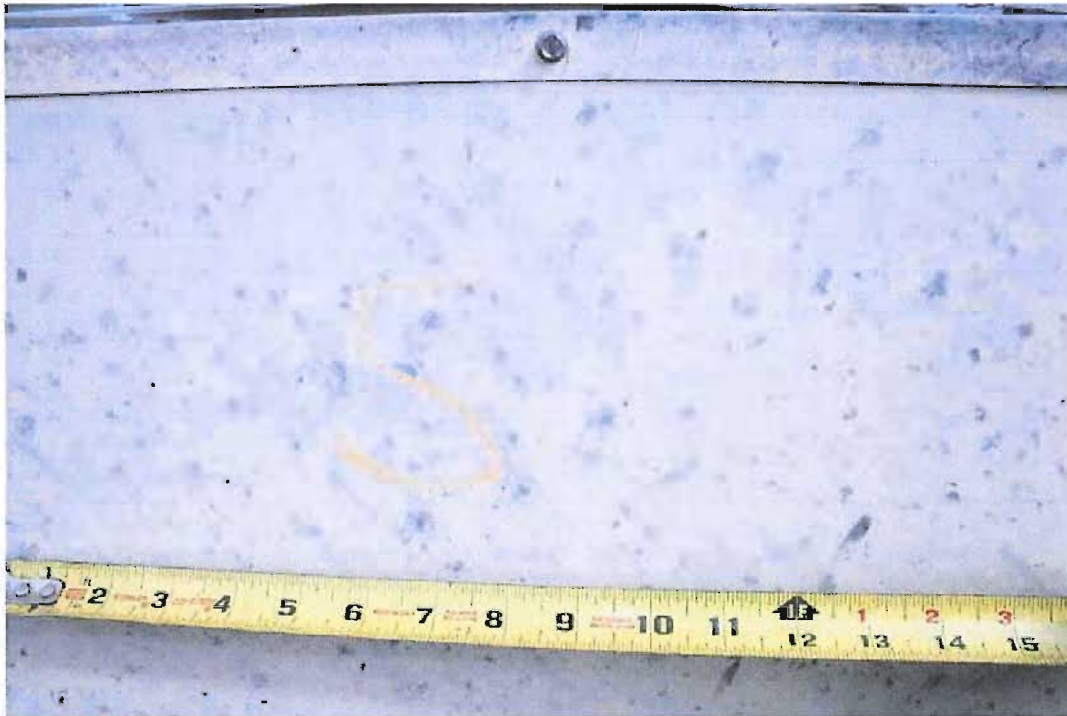
We checked various appurtenances looking for evidence of hailstone impact. Hail-caused spatter marks were visible on the air conditioner cabinets. The marks were caused when hail impacted and removed some of the oxidation on the painted metal cabinets. Hail-caused spatter marks measured up to 3/4 inch in diameter on the tops of the units with smaller sized spatter marks on the north, west, and south sides of the units. Hail-caused dents up to 3/4 inch in diameter were measured in the exposed, south-facing, aluminum fins on three Lennox air conditioners. The nameplates on the Lennox units were worn so we were unable to determine the dates the units were manufactured. Rheem air conditioners had dates of manufacture ranging from September 1999 through October 2010. Fins were protected by louvers on these units. (Refer to Photographs 51 through 56.)

51. 4201 BLDG – Hail-caused spatter marks on south side of metal air conditioner cabinet.

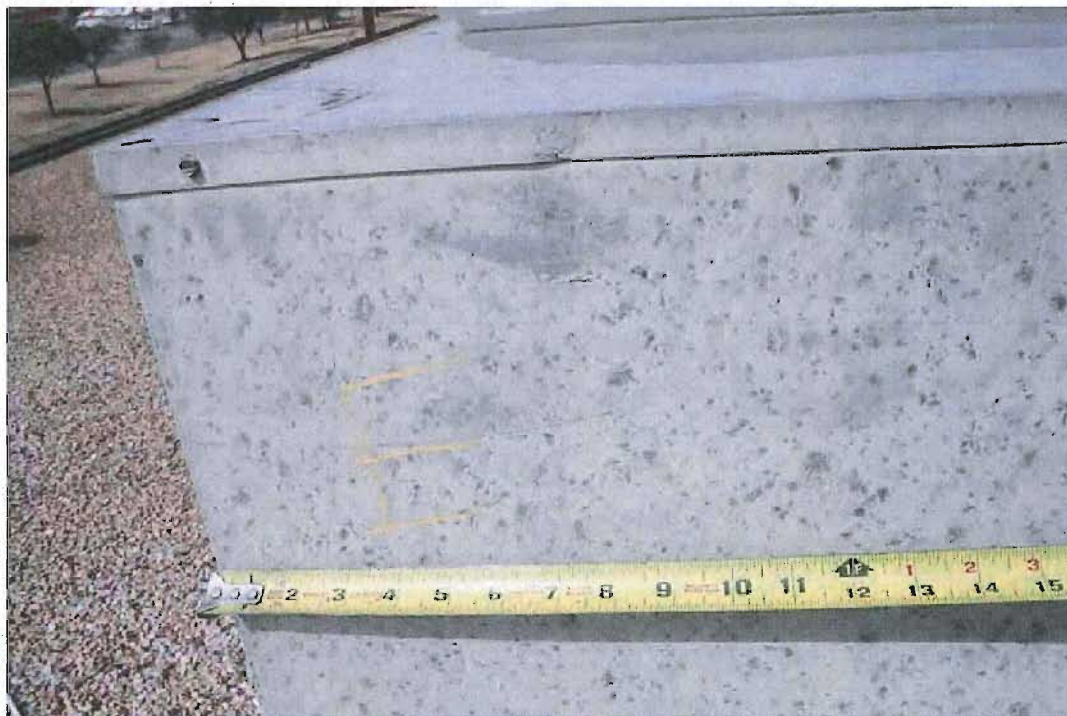
52. 4201 BLDG – Hail-caused spatter marks on east side of metal air conditioner cabinet.

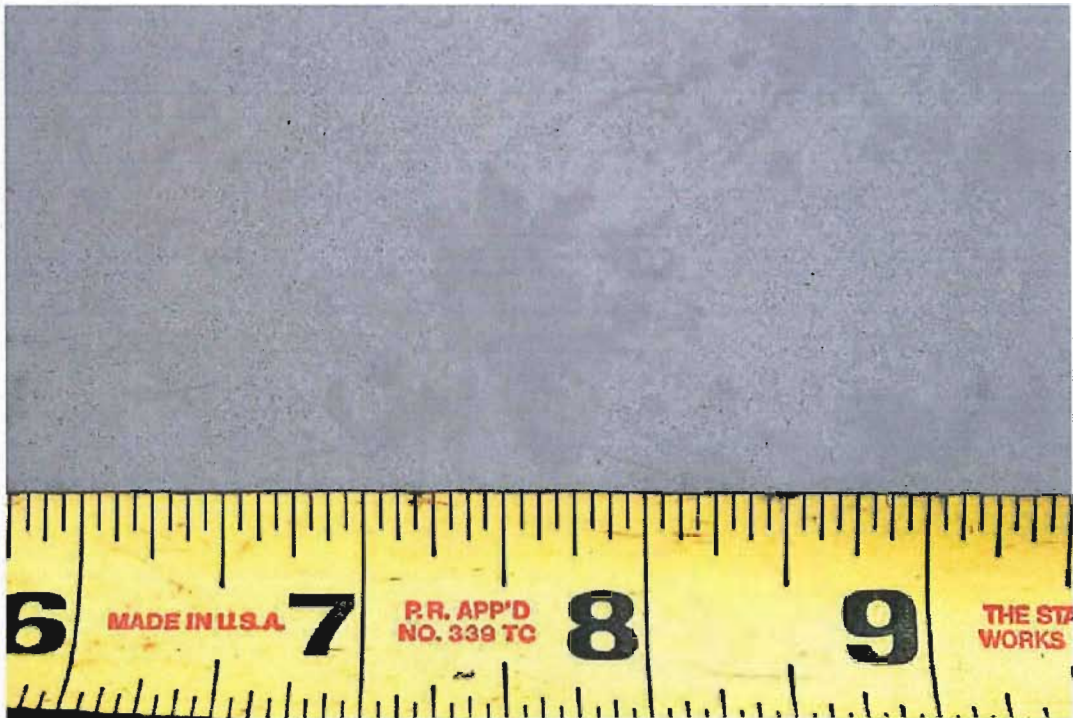
53. 4201 BLDG – Close-up view of largest spatter mark found on top of metal air conditioner cabinet.

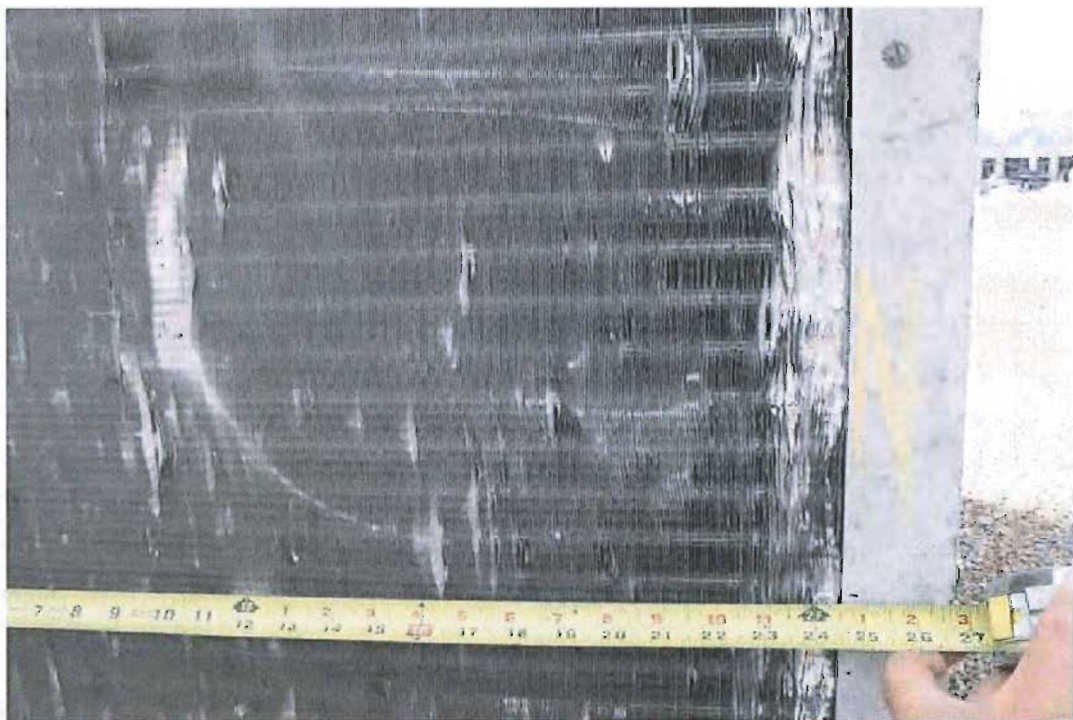
they were not coincident with the spatter marks on the panels. No hail-caused bruises, punctures, or spalled areas were found to the built-up roofs at the 4130 and 4201 North First Street locations. Likewise, the cedar shake mansard and three-tab shingles in back of the mansard did not exhibit any hail-caused damage. Additional dents could have occurred to the exposed aluminum fins on three Lennox air conditioners; the dented fins can be combed.

54. 4201 BLDG – Hail-caused dents in north facing fins on air conditioner.

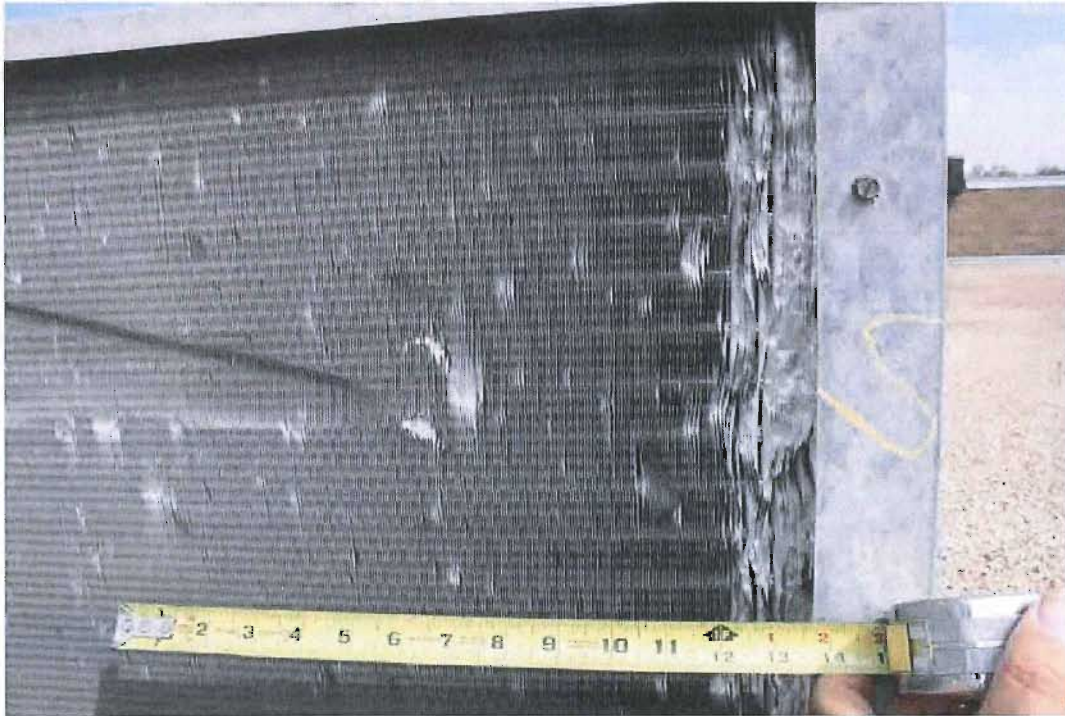
55. 4201 BLDG – Hail-caused dents in south facing fins on air conditioner.

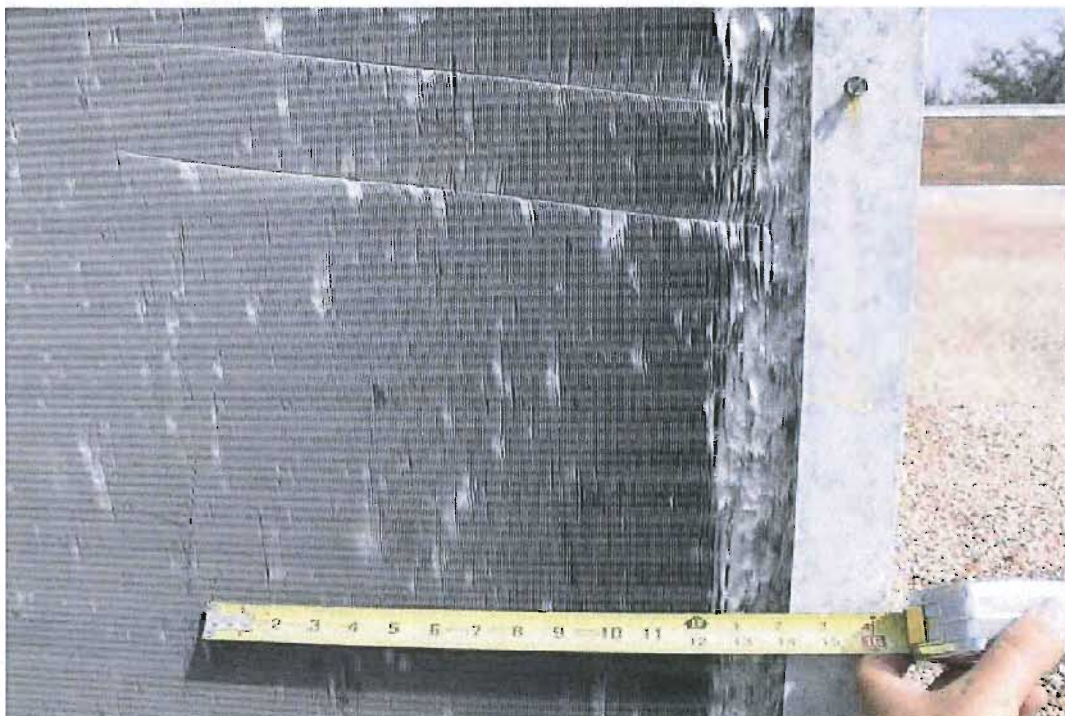
56. 4201 BLDG – Hail-caused dents in south facing fins on air conditioner.

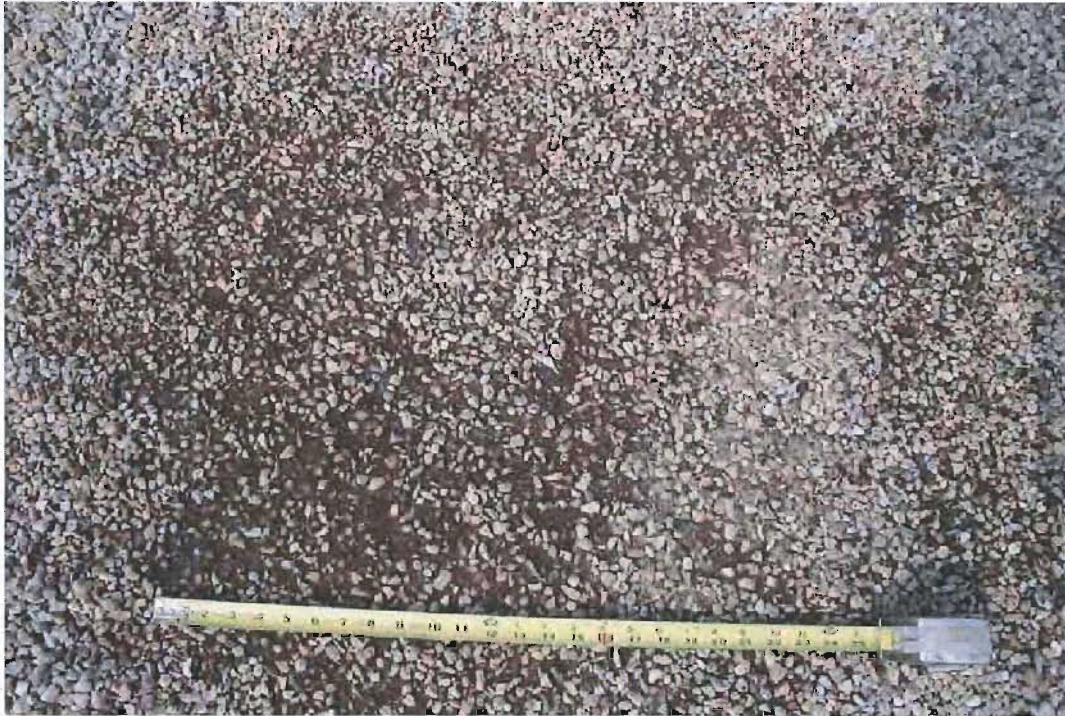
Examination of the built-up roof revealed no hail-caused bruises, punctures or spalled areas in the roof surface. Even exposed areas of the built-up membranes along curbs and parapets were notably absent of hail-caused damage. Likewise, no hail-caused bruises were found in the three-tab asphalt shingles on the back side of the mansard or to the modified bituminous membrane on the expansion joint. No hail-caused splits were found in the cedar shake mansard. (Refer to Photographs 57 through 64.)

57. 4201 BLDG – Lack of hail-caused damage to built-up roof.

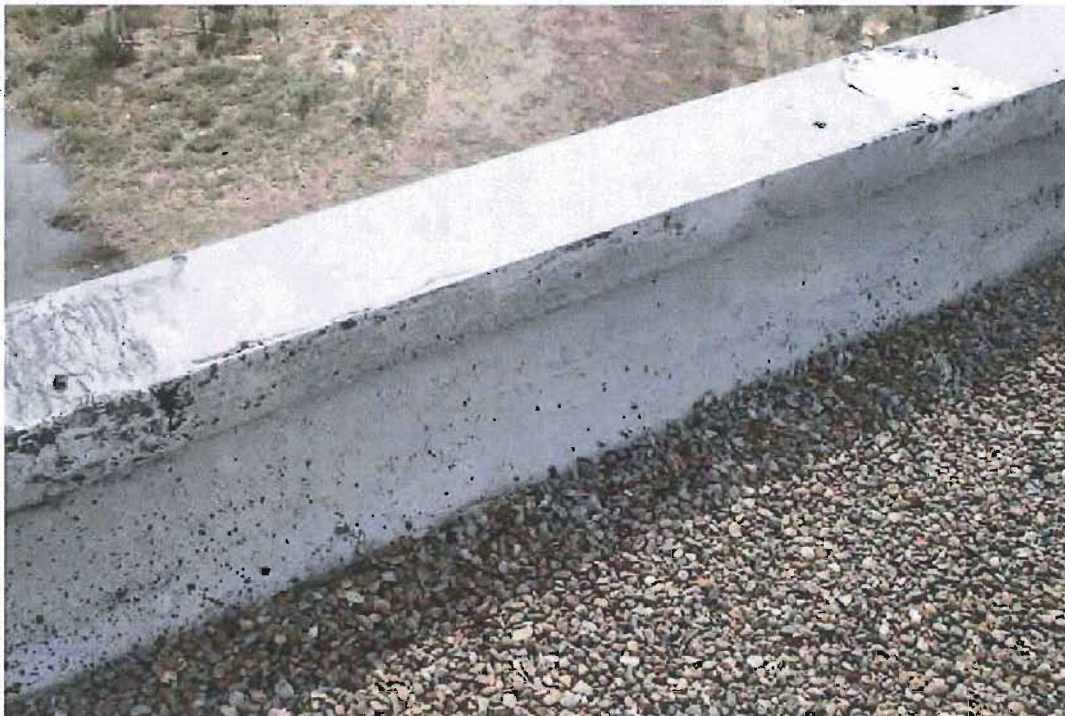
58. 4201 BLDG – Lack of hail damage to west facing parapet flashing.

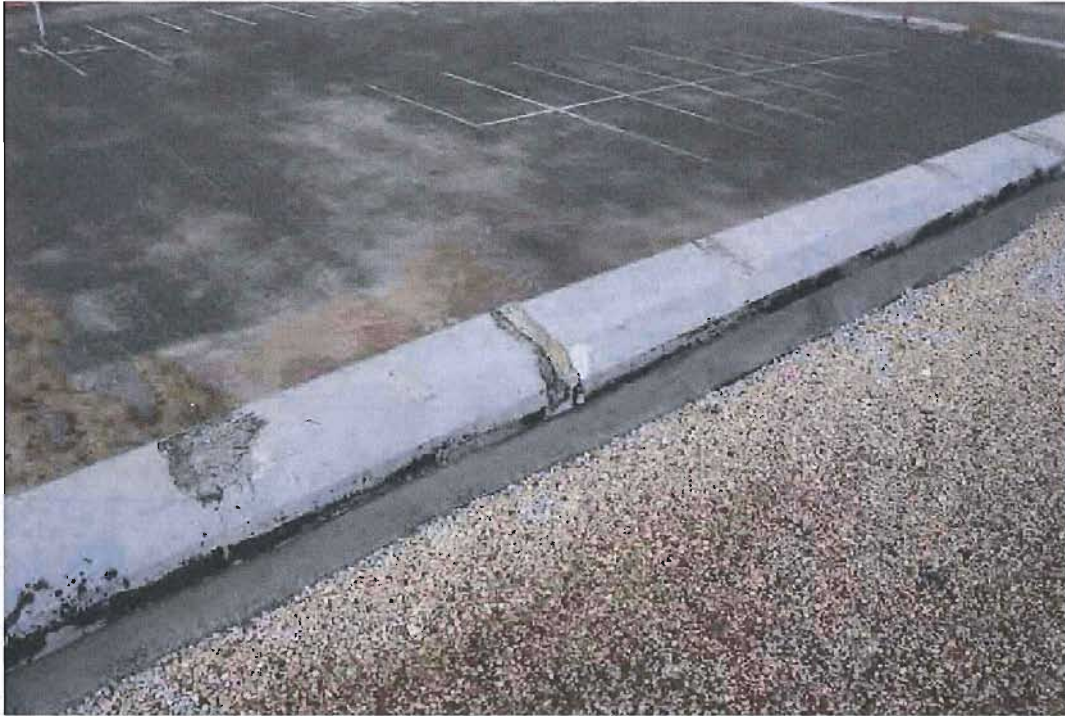
59. 4201 BLDG – Lack of hail damage to east facing parapet flashing.

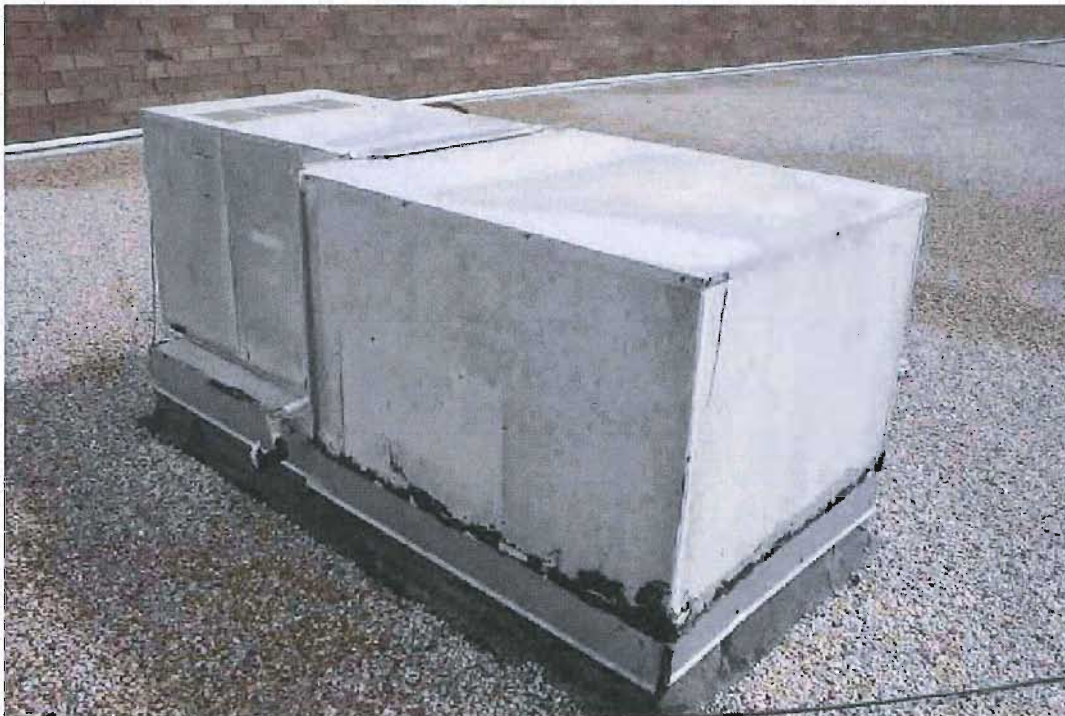
60. 4201 BLDG – Lack of hail damage to curb flashing around air conditioners.

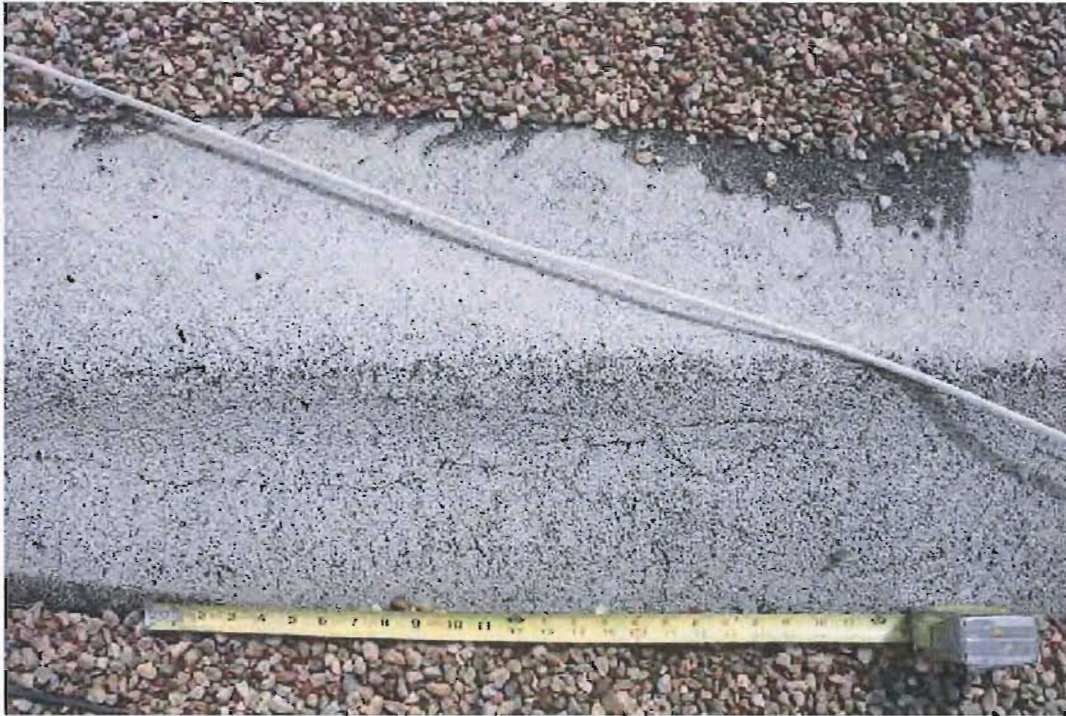
61. 4201 BLDG – Lack of hail damage to modified bituminous membrane on expansion joint.

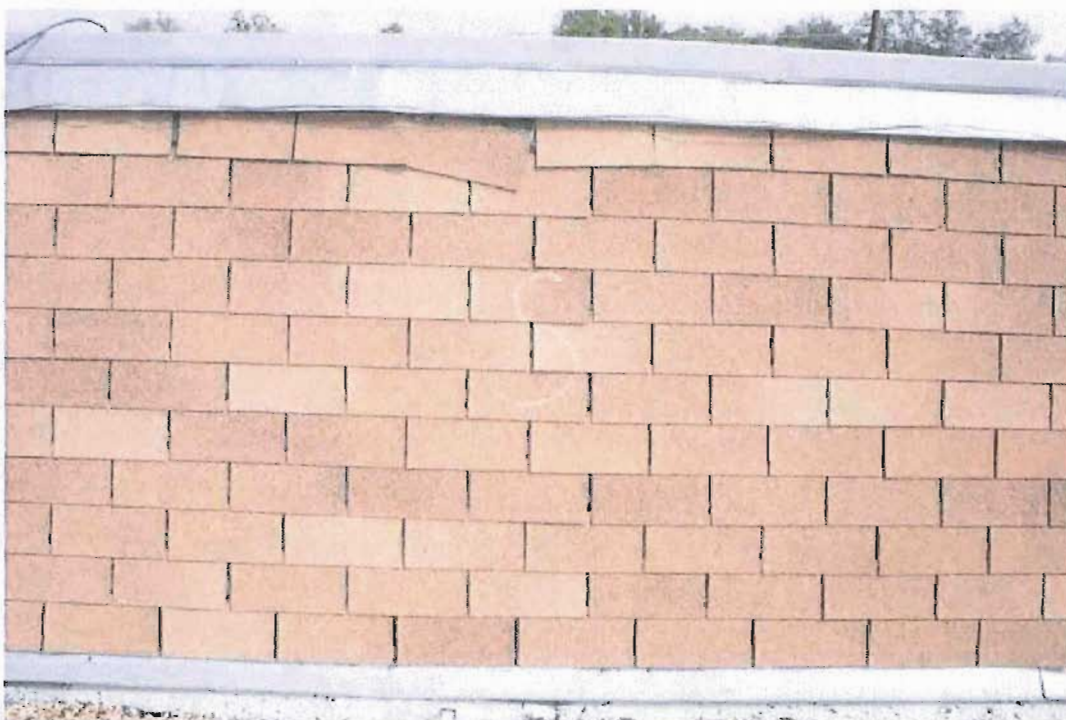
62. 4201 BLDG – Lack of hail damage to asphalt shingles, south slope.

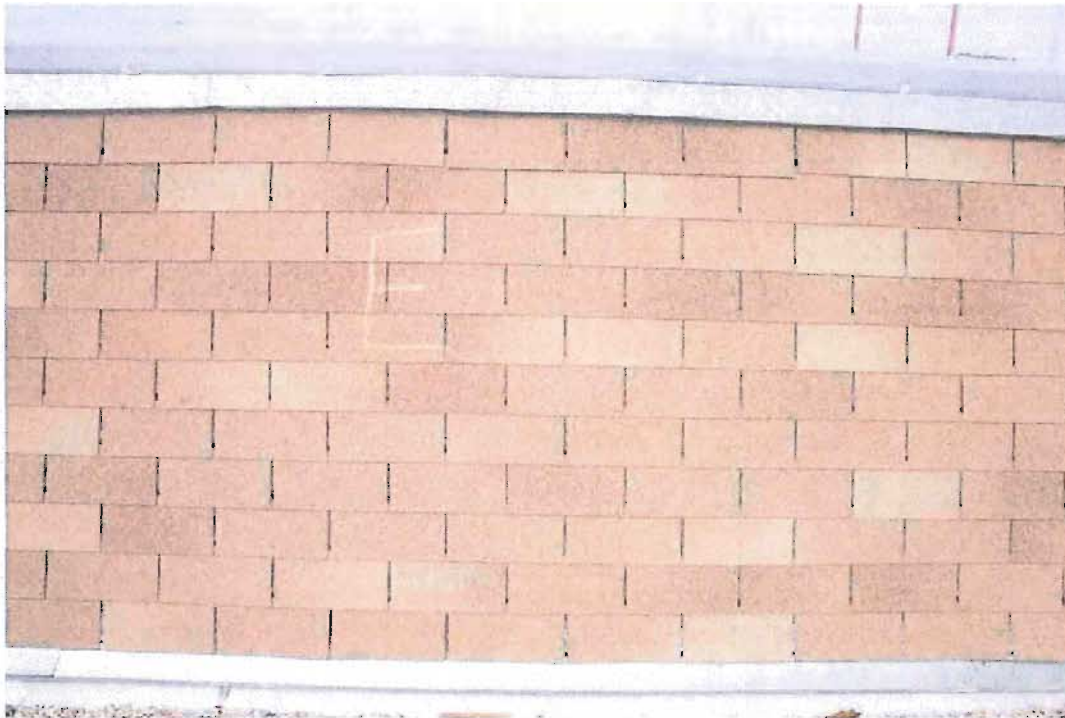
63. 4201 BLDG – Lack of hail damage to asphalt shingles, east slope.

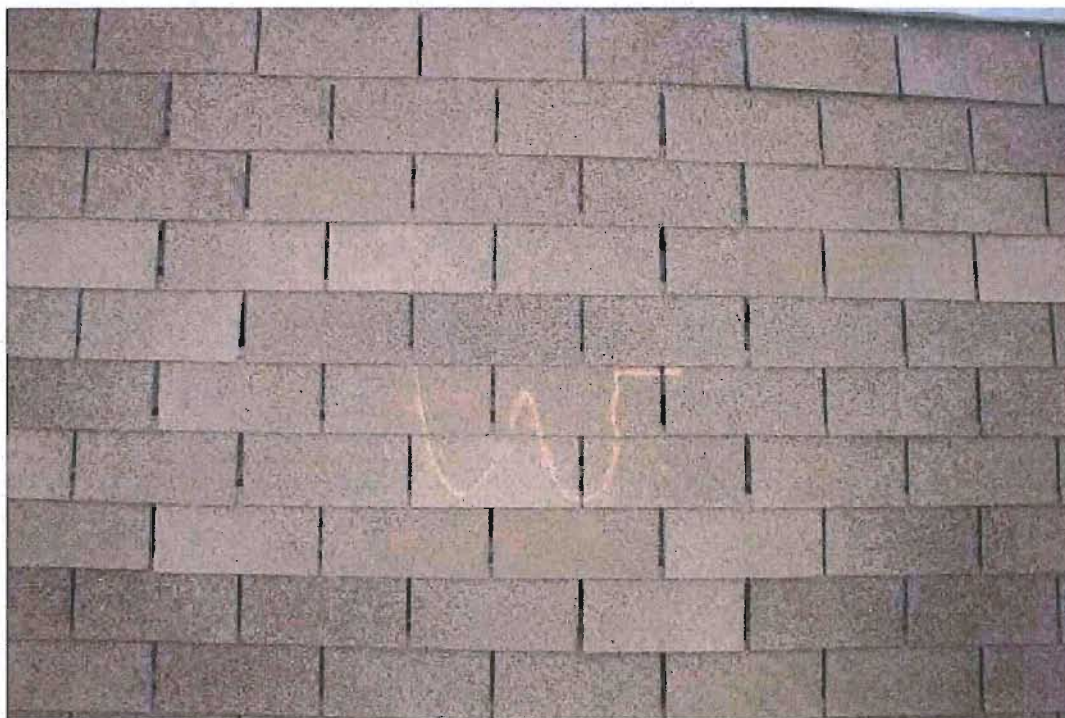
64. 4201 BLDG – Lack of hail damage to asphalt shingles, west slope.
